CIVIL ENGINEERING STUDIES
Hydraulic Engineering Series No. 50

HYDRAULIC MODEL STUDY FOR THE DROWN PROOFING OF YORKVILLE DAM, ILLINOIS

**HYDROSYSTEMS LABORATORY
DEPARTMENT OF CIVIL ENGINEERING
UNIVERSITY OF ILLINOIS AT URBANA-CHAMPAIGN
URBANA, ILLINOIS**

May 1996

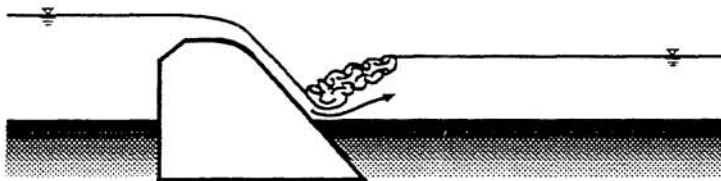
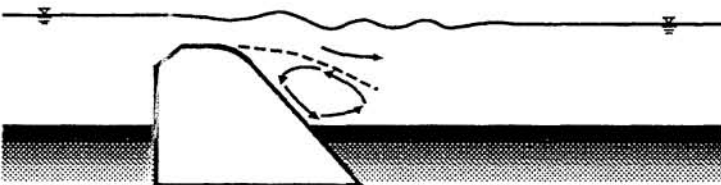
Case A
Swept-Out
Hydraulic Jump

Case B
Optimum
Hydraulic Jump

Case C
Submerged
Hydraulic Jump

Case D
Surface
Nappe

Case E
Submerged Hydraulic
Jump with Scour Hole

Figure 1.2 States of spillway flow as a function of tailwater depth.

Figure 1.2 depicts the four tailwater conditions that could develop below a low overflow structure with a flat bed, as well as the condition that develops for a scoured-out bed. Condition A occurs for low tailwater, which causes the jump to be swept away from the toe of the spillway. As the tailwater rises, the jump starts to move closer to the spillway. It continues to move closer until the tailwater has reached an optimal depth where the toe of the jump is right at the toe of the spillway (Condition B). A further increase in tailwater depth drowns the hydraulic jump and it becomes submerged (Condition C). The plunging flow generates a roller as its mechanism for energy dissipation. The roller axis is in the spanwise direction to the flow. This roller is commonly called the "hydraulic" by canoeists and water safety experts who understand its power to capture unwilling victims (Leutheusser, 1988).

The jump will become submerged to various degrees depending on the height of the tailwater. Eventually, the tailwater rises to such a high level that the submerged hydraulic jump disappears and the flow barely notices the presence of the spillway (Condition D). The surface will become undular, and then eventually flat at extreme tailwater levels.

Conditions A - D have been described before (Leutheusser and Birk, 1991; Leutheusser, 1988), but it is interesting to observe the effects of tailwater depth on the hydraulic jump when there is a scour hole at the toe of the spillway. The presence of a scour hole, whether it is the shape

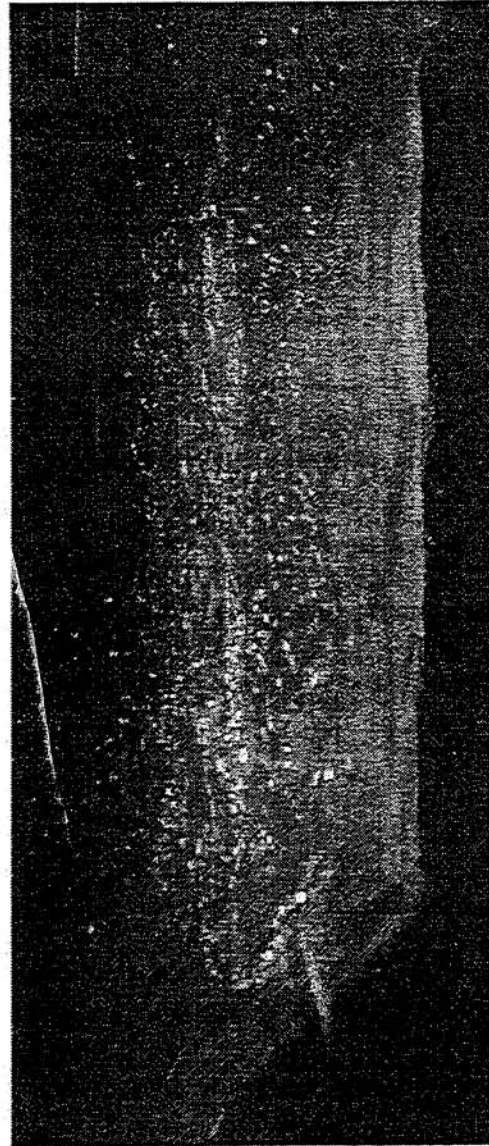
Figure 6.3: Grouted Pad at $Q = 10,000$ cfs.

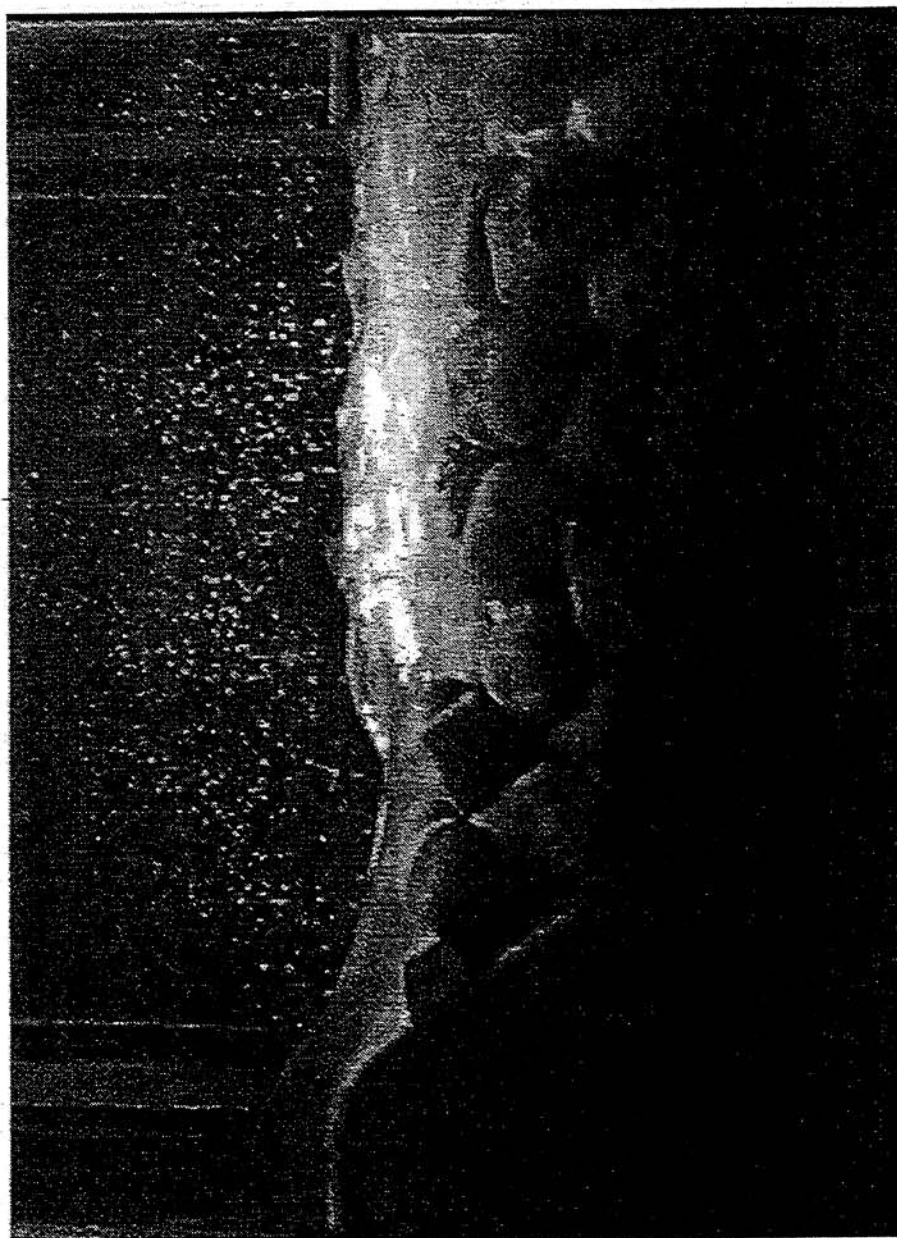
Figure 6.5: 10:1 Sloping boulder alternative at $Q = 10000$ cfs.

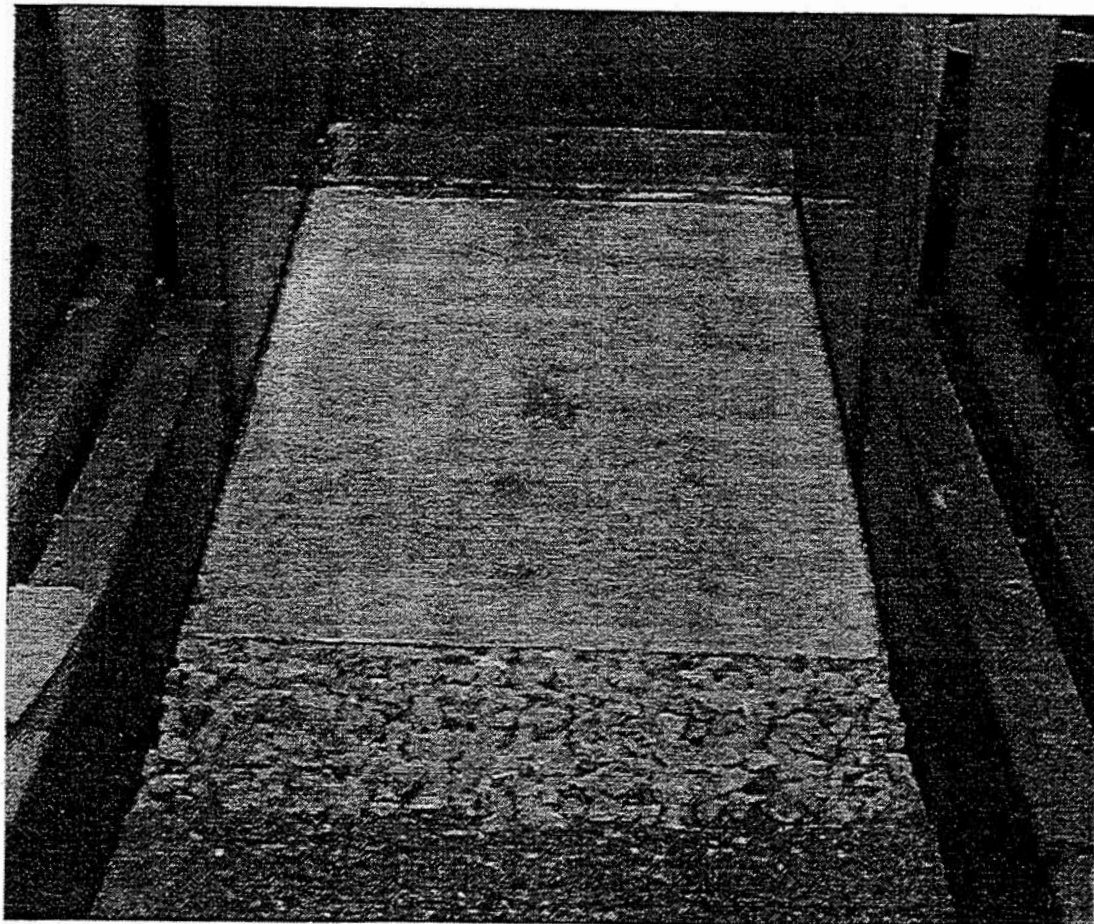
Figure 6.6: 10:1 Sloping Smooth Face Alternative

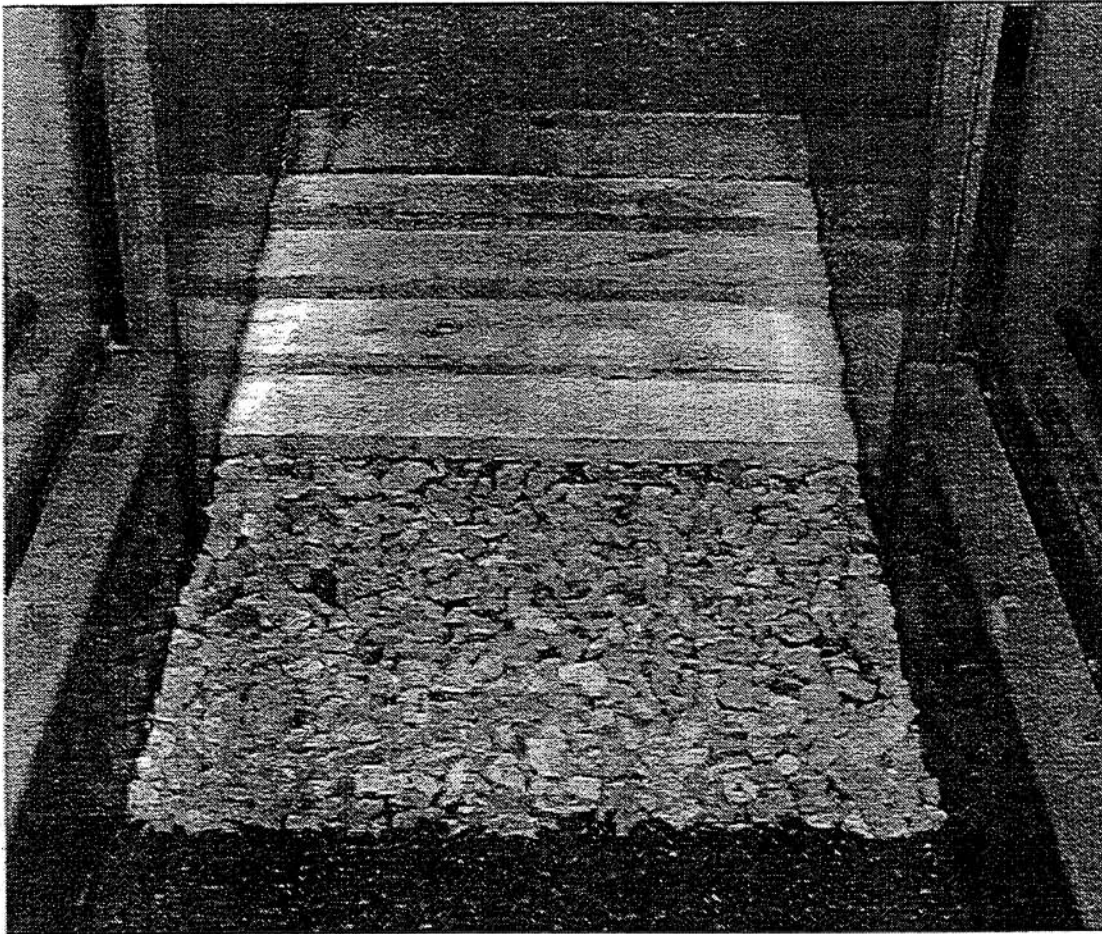
Figure 6.8: Four-Step Spillway Alternative

Since the bed resides at an elevation of 569.00 ft MSL, there was 4.5 feet of step height to work with. For a four-step structure this set the step height at 1.125 feet. To achieve the l/h ratio of 5, this set the step length at 5.625 feet. The riprap type 1 from the 1977-78 design was built up to an elevation just below 569.00 ft MSL. A thin layer of masonry sand was placed on top of the riprap and then the rigid concrete cast steps were placed on top of that. This set the bottom of the steps at an elevation of 569.00 ft MSL. Beyond the stepped structure, riprap type 2 was placed.

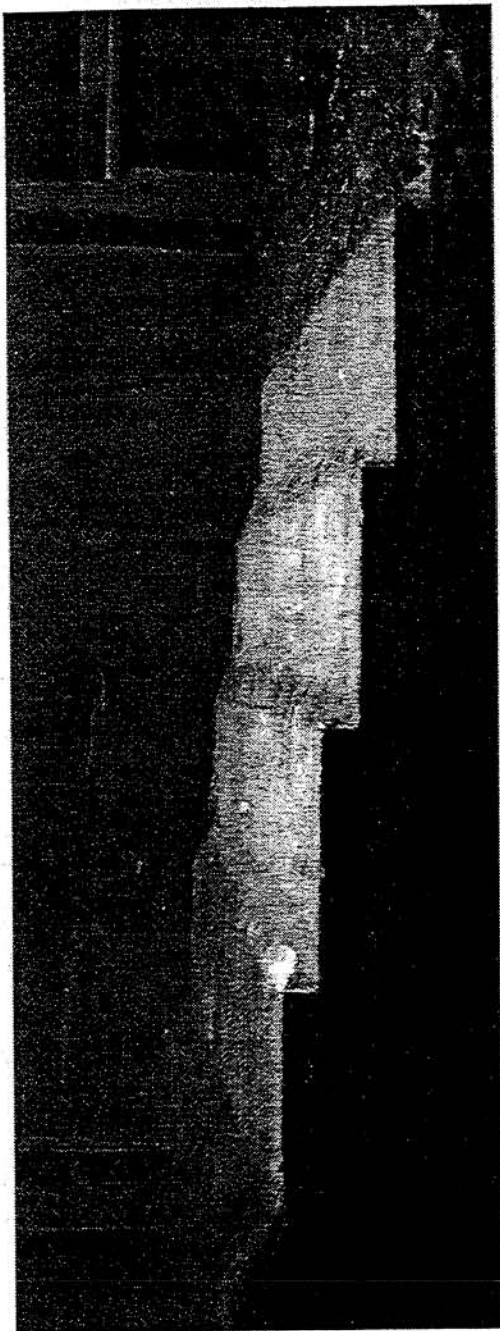
Figure 6.9: Four-Step Spillway at $Q = 1000$ cfs.

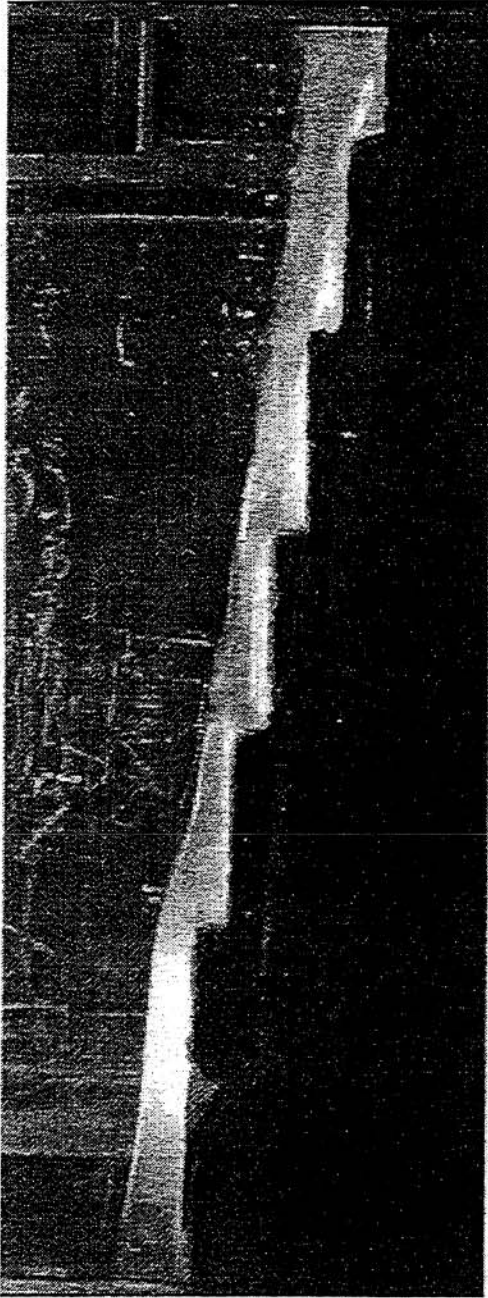
Figure 6.14: Six-Step Spillway at $Q = 5000$ cfs.

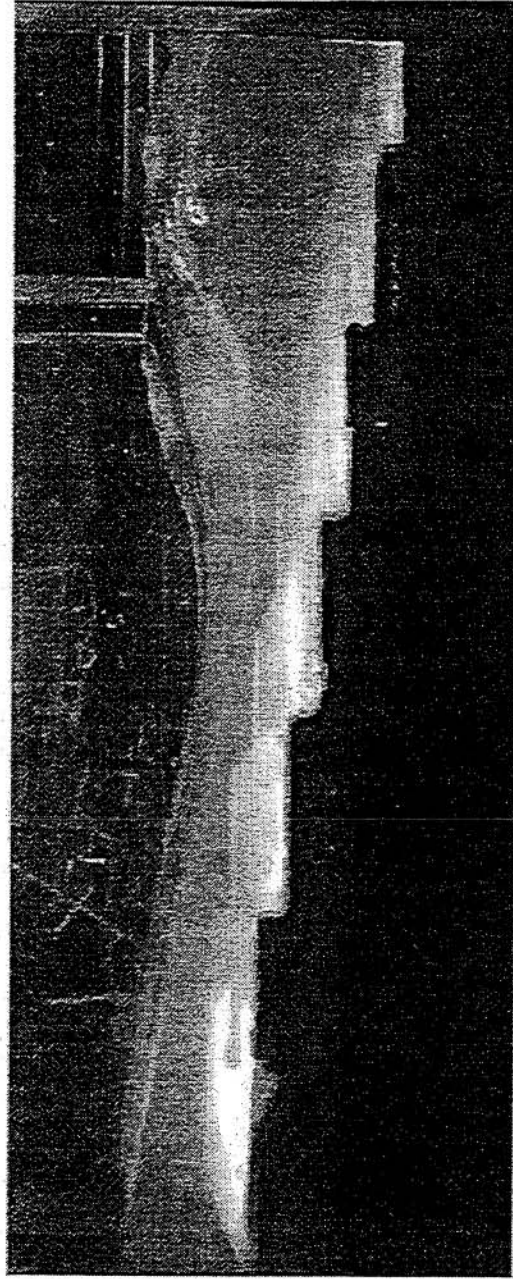
Figure 6.15: Six-Step Spillway at $Q = 17000$ cfs.
